## Changes in water and habitat quality in the Patuxent River

2015 Patuxent River Conference  
June 18, 2015

Renee Karrh  
Maryland DNR

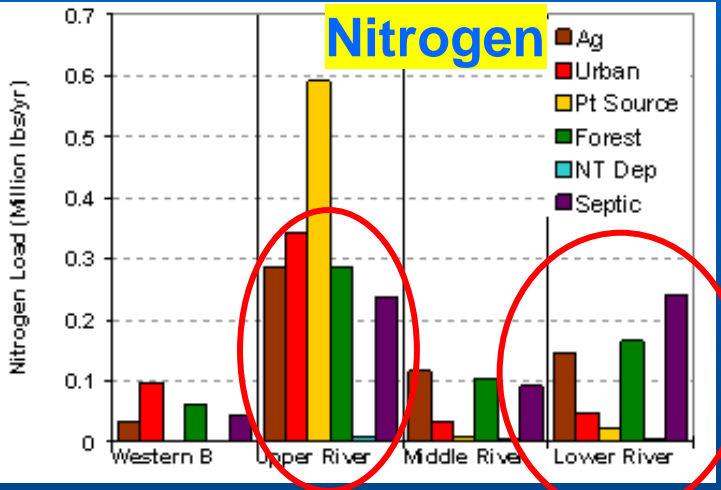
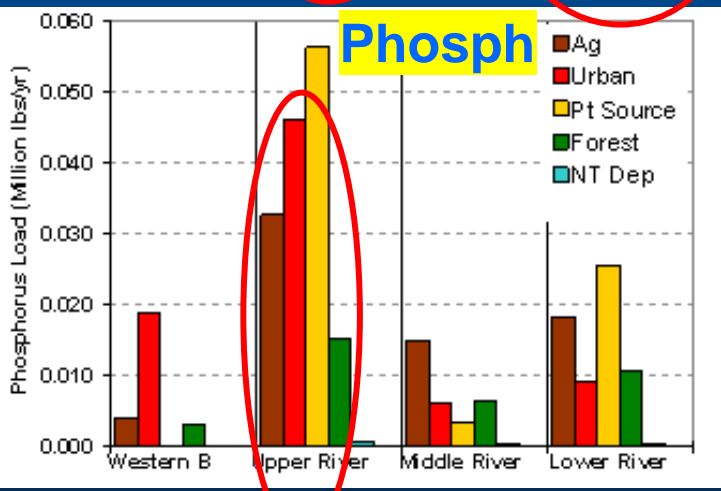
# Nitrogen & Phosphorus Loadings per year

- Point Sources largest source in Upper River
- Septic important to Nitrogen loads
- Urban and Agriculture Sources

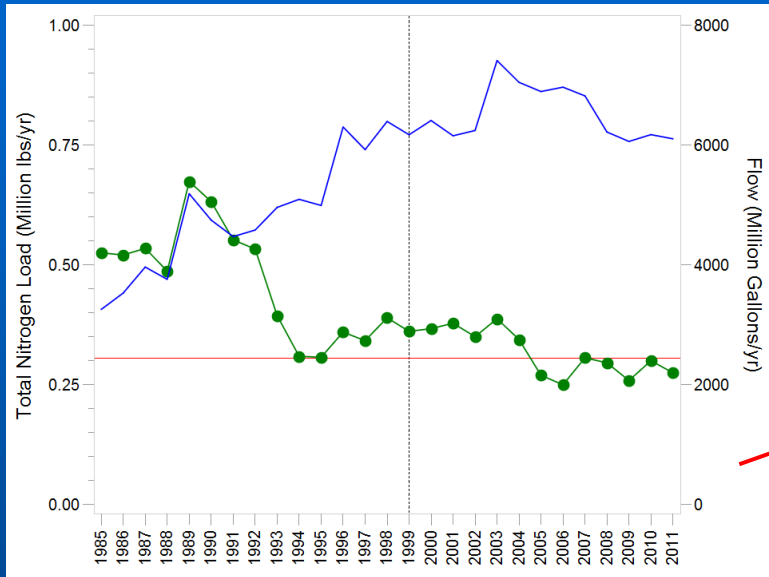
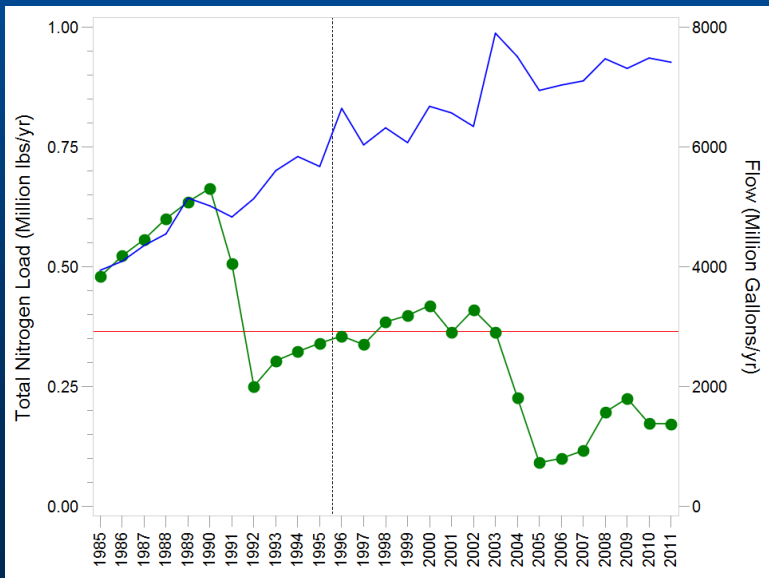
# Nitrogen & Phosphorus WWTP Loadings per year

## ENR upgrades completion dates

**Nitrogen (green)**  
**Flow (blue)**

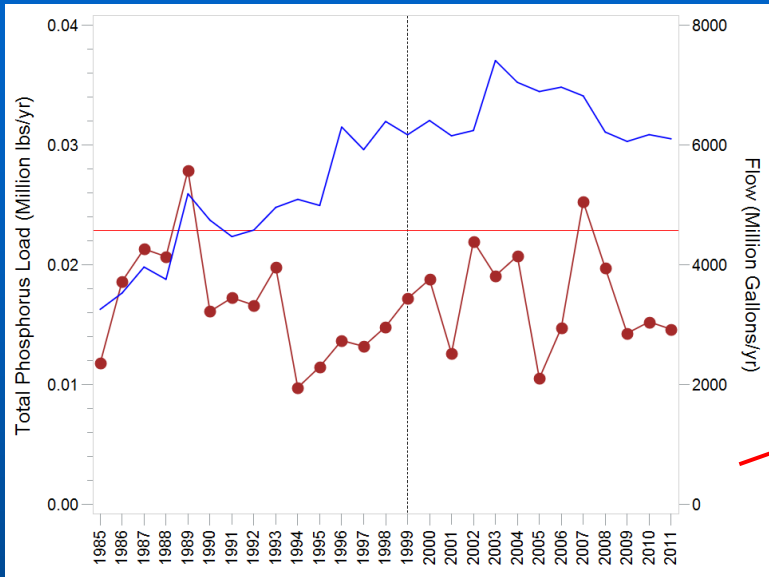
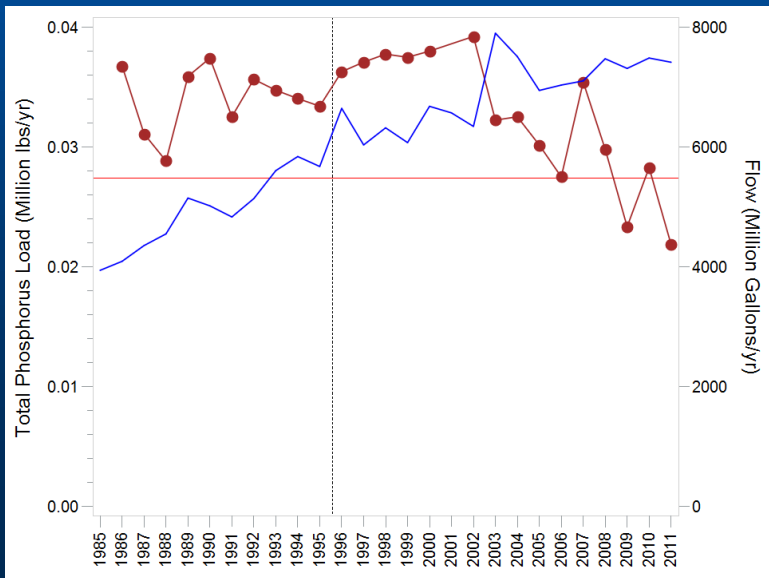
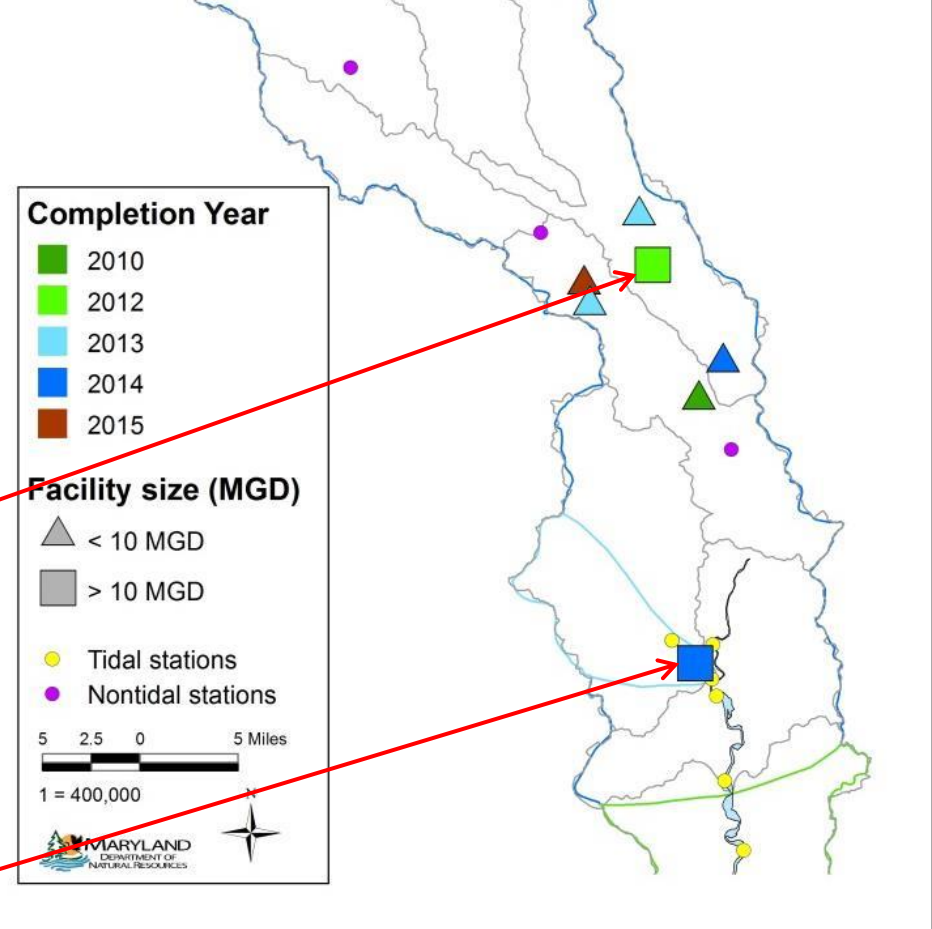
# Nitrogen & Phosphorus WWTP Loadings per year

## ENR upgrades completion dates

Phosphorus (brown)  
Flow (blue)

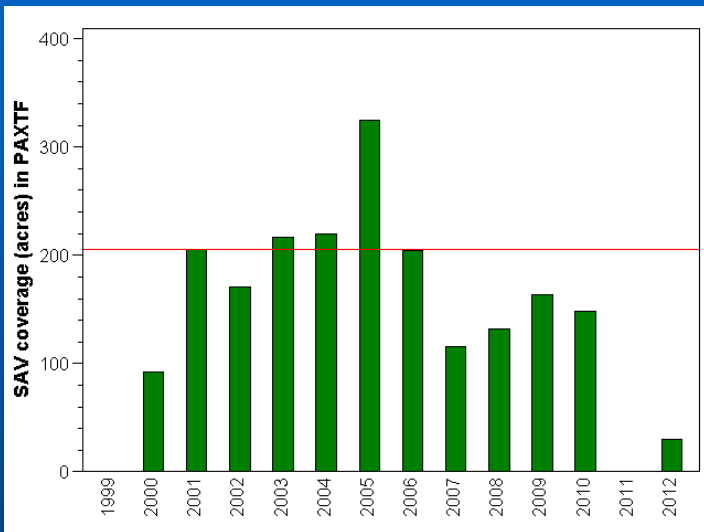
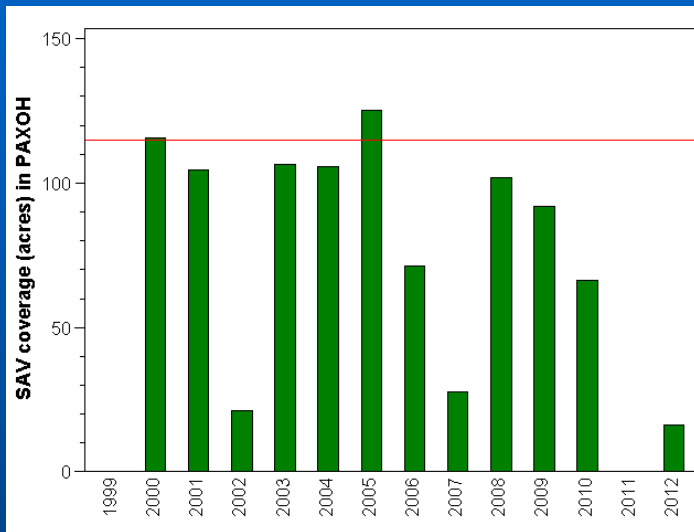
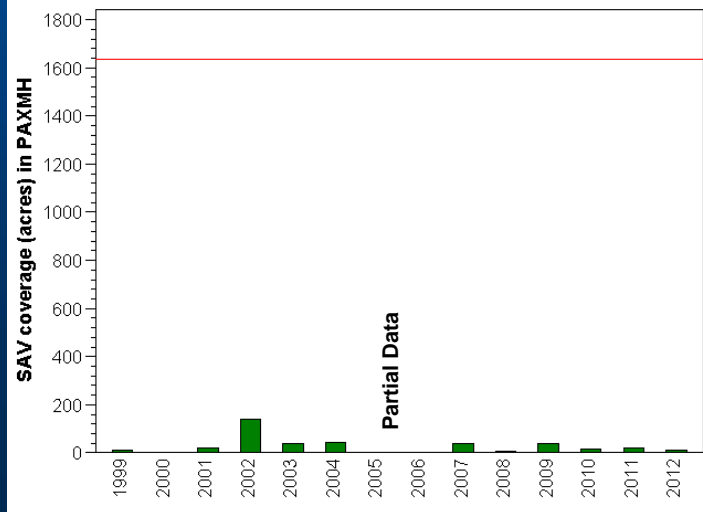
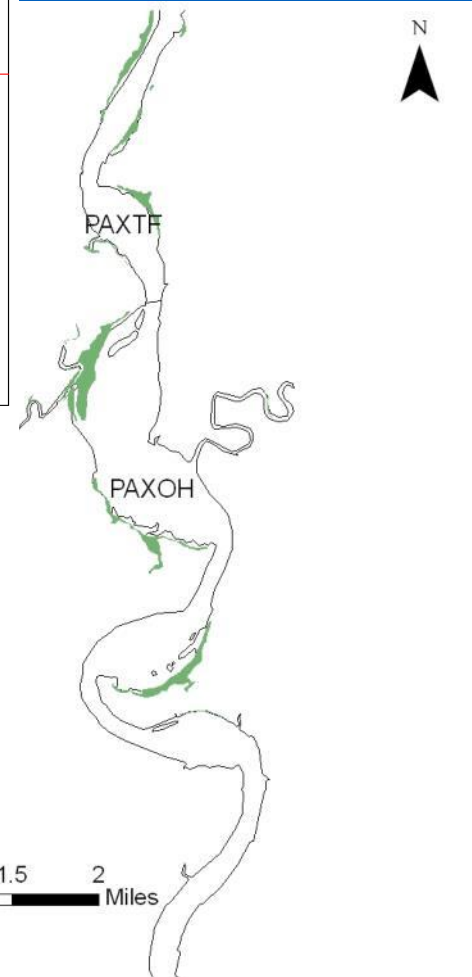
# Underwater grasses (SAV)

SAV acres by Bay Program segment 1999-2012

SAV coverage maps 2010\* used 2010 because of large decrease in 2012
